3M ESPE

Making Better Impressions

Guide

A Troubleshooting Guide

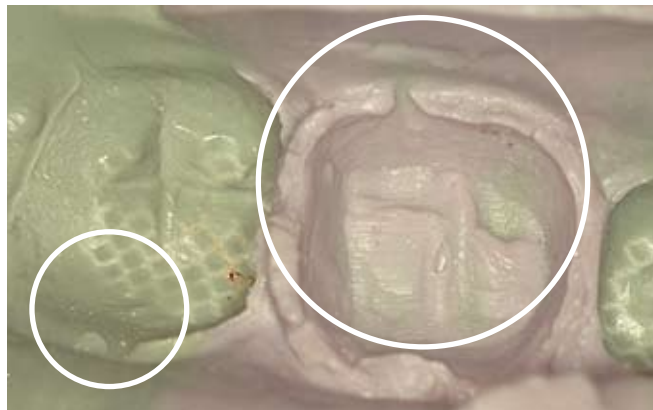
Void Caused by Syringe Technique

CAUSE	SOLUTION
Air trapped in intraoral syringe.	Properly bleed filled elastomer syringe. Keep tip immersed in material when loading syringe. Do not stop when in the middle of loading syringe.
Air trapped while filling impression tray.	Keep mix tip immersed in tray material while filling the tray.
Improper syringe technique.	Keep syringe tip immersed in wash material to avoid entrapping air. Wiggle and stir while syringing. Push material forward.
Inadequate coverage of marginal area with light body impression material.	Use wash material liberally on preparation and abutments.

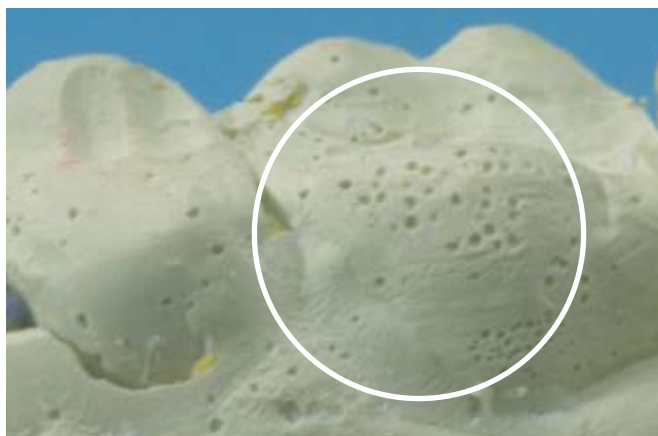
Stone Model with Hydrogen Evolution Voids

Hydrogen gas emission.

Follow manufacturer’s instruction for casting time.
