**3M** ESPE

Making Better Impressions

# Making Better Impressions

## A Troubleshooting Guide

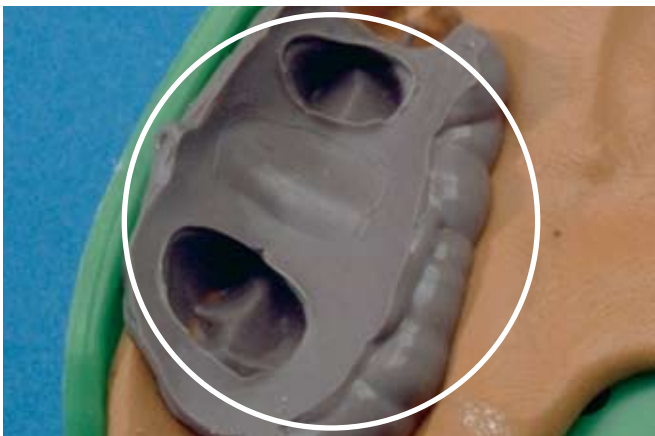
Exceeding the Working Time

CAUSE	SOLUTION
Exceeding the working time.	Follow manufacturer's working time specifications.  Choose material with longer working time.
Tray movement or repositioning after seating.	Do not move tray after seating.
Insufficient amount of impression material used.	Use more material to create back flow effect.
Impression tray does not support flow of impression material.	Use lingual stops.  Use an impression tray that supports the flow of the material.

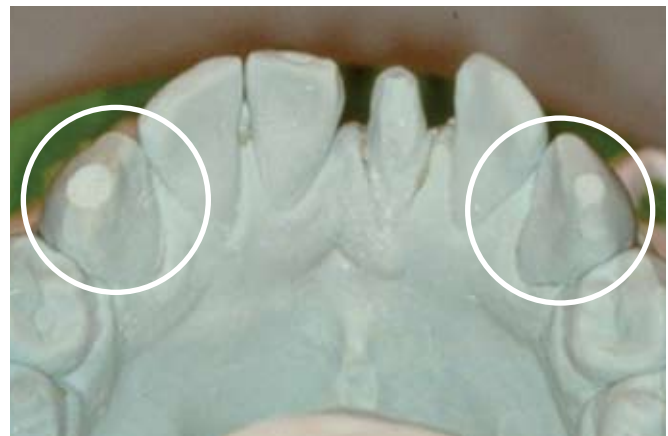
Stone Model with Powdery Cusp Tips
